# TESTING AND EVALUATION OF MASH TL-3 TRANSITION BETWEEN GUARDRAIL AND PORTABLE CONCRETE BARRIERS

MwRSF Research Report No. TRP-03-335-17

May 2, 2017

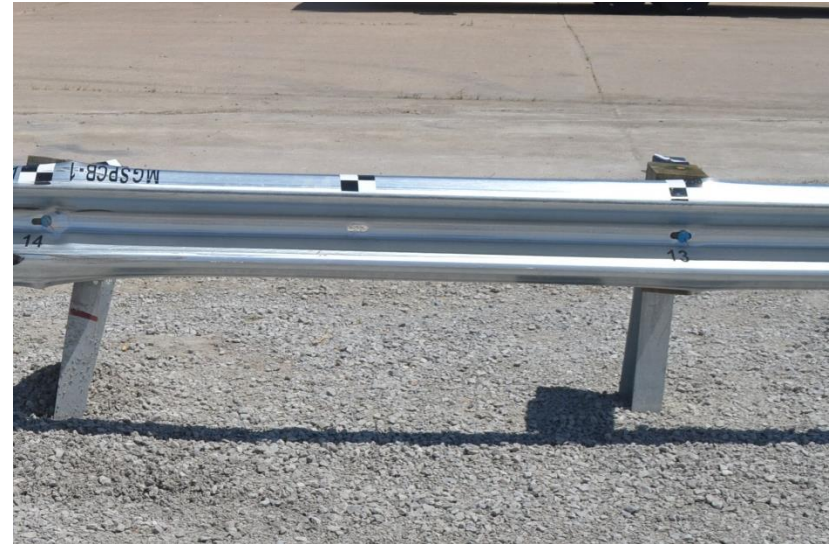
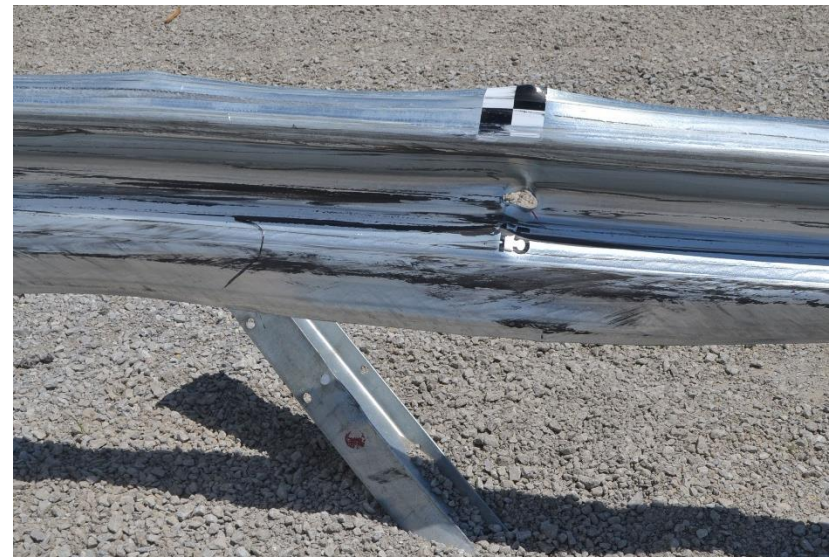
Figure 66. System Damage Between Post Nos. 12 and 15, Test No. MGSPCB-1

Post no. 1 had vertical cracking at the middle of the front face along the entire length, and post no. 2 had cracking on the upstream side extending outward from the BCT hole. Post nos. 3 through 13 twisted downstream, and the front face of their blockouts had dents and gouging from the guardrail. The front flange of post no. 14 partially twisted clockwise along the length of the

blockout, and blockout no. 14 had cracking on the bottom front upstream corner. Contact marks began 14¾ in. (375 mm) upstream of post no. 14 and were due to the right-rear corner of the vehicle slapping the guardrail after the initial impact. The bottom corrugation of the guardrail flattened from 13 in. (330 mm) upstream of post no. 15 to post no. 17. Post no. 15 had a dent in the front flange 17 in. (432 mm) from the top, and blockout no. 15 disengaged from the rail due to bolt shear. Post no. 16 twisted and bent downstream with the downstream side of the post against the upstream face of concrete barrier no. 1. The downstream flanges of post no. 16 were bent outward, and the steel fractured at the downstream bottom blockout holes. Blockout no. 16 was partially fractured, and the post bolt was bent 90 degrees. Post no. 17 bent downstream, and the blockout was partially fractured. The top back upstream flange of post no. 17 was bent inward. Post no. 18 had a dent located 2 in. (51 mm) above the ground line on the back downstream flange. A kink formed on the top corrugation, extending from 11½ in. (292 mm) upstream of post no. 18 to 17 in. (432 mm) downstream of post no. 18. The blockout mounts that connected the rail to the PCB, and the mount for the end shoe transition were undamaged.
